Panels of HDG G60 (Bare) and HDG G30 with InterCoat® ChemGuard 315L were exposed to a Gravelometer (Stone-Chip) according to ASTM D3170, followed by accelerated corrosion testing according to ASTM B117. All test panels exposed to Gravelometer had similar dings and dents. In the below photograph, the surface of a test panel has been magnified & adjusted for lighting in order to highlight the damage to the panels.

After exposure to ASTM D3170, panels were exposed in ASTM B117 Salt Spray for a maximum of 1,750 Hours of Exposure. There were duplicate panels of each variable exposed to stone-chip conditions - these duplicate panels were not exposed to the Gravelometer and were held out in order to be used as side x side controls, allowing the lab to observe the differences in failure mode when a substrate undergoes significant damage in the form of Stone-Chip.

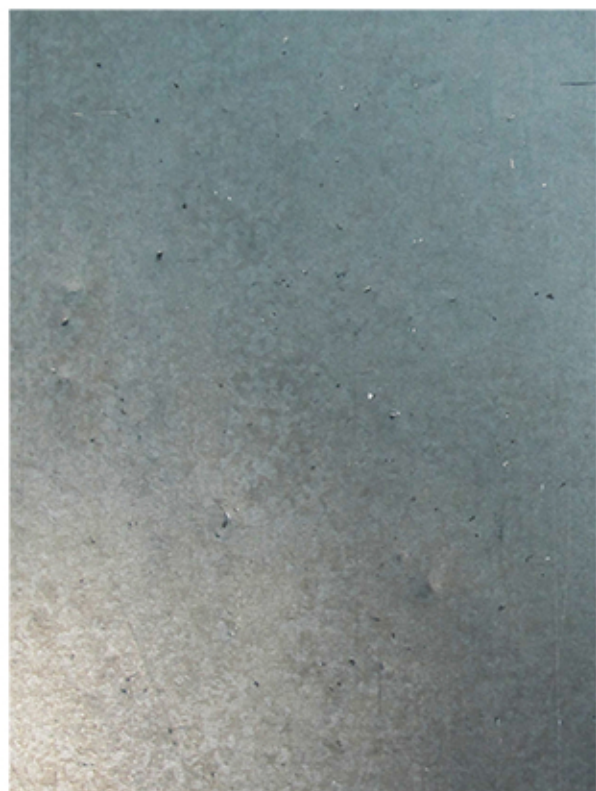
Magnified/Lighting Adjusted

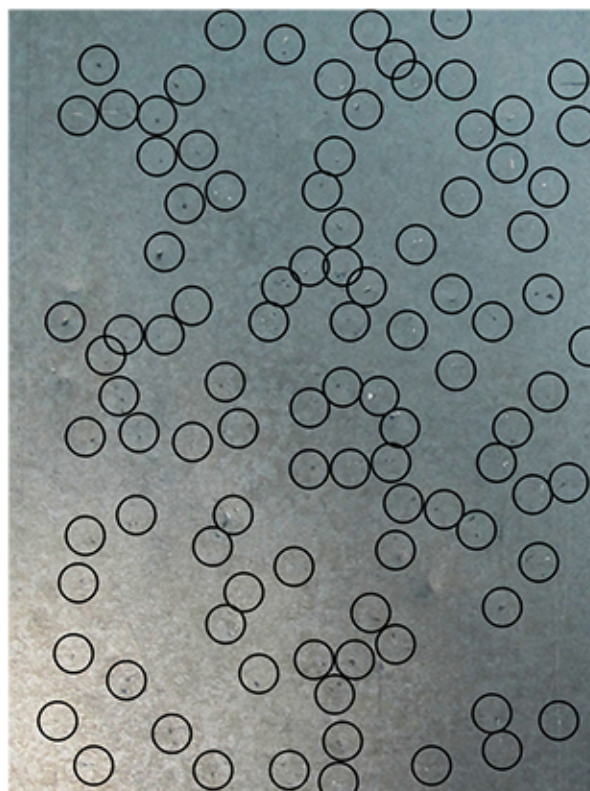
***Magnified/Lighting Adjusted
with Dings/Dents Circled***

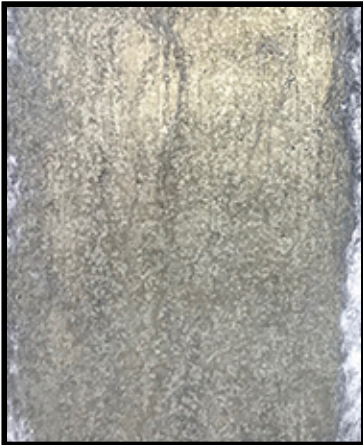
Exposed 500 Hours in ASTM B117

Exposed to Gravelometer
HDG G30
InterCoat® ChemGuard 315L

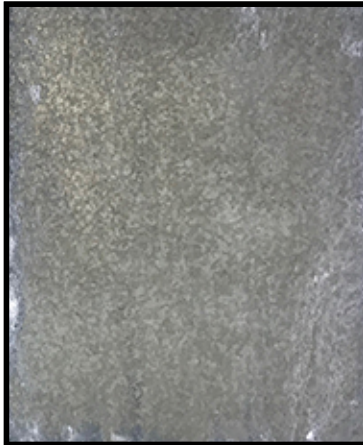
Control - No Exposure
HDG G30
InterCoat® ChemGuard 315L

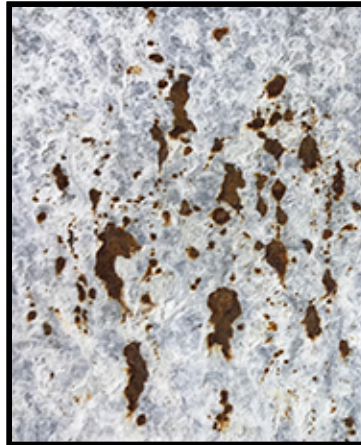
Exposed to Gravelometer
HDG G60
Bare - No Coating

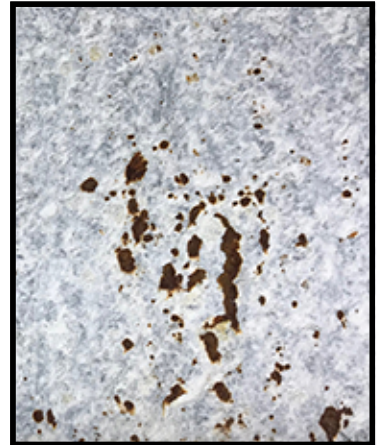
Control - No Exposure
HDG G60
Bare - No Coating

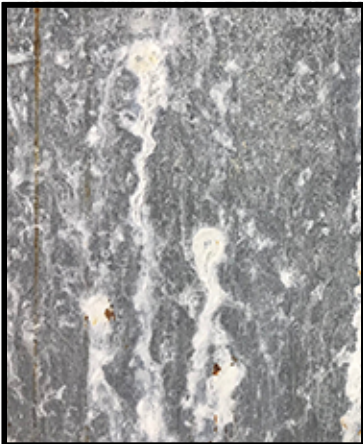
Exposed 1,000 Hours in ASTM B117

Exposed to Gravelometer
HDG G30
InterCoat® ChemGuard 315L

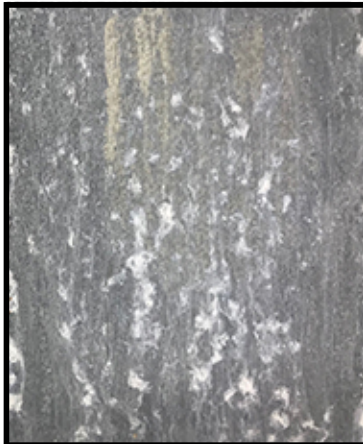
Control - No Exposure
HDG G30
InterCoat® ChemGuard 315L

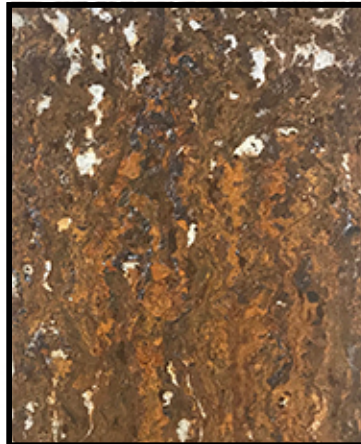
Exposed to Gravelometer
HDG G60
Bare - No Coating

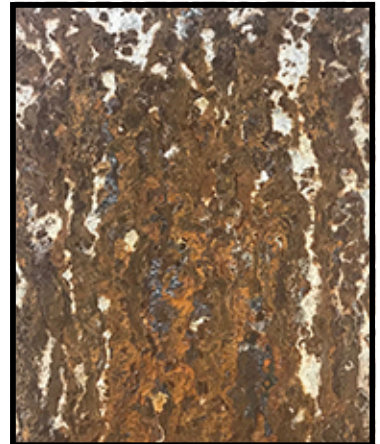
Control - No Exposure
HDG G60
Bare - No Coating

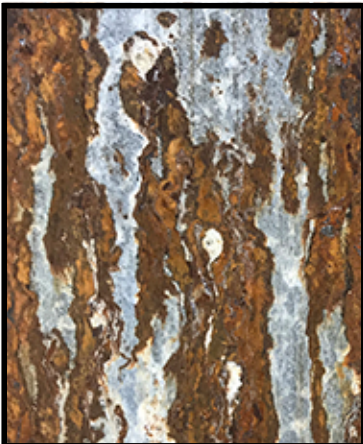
Exposed 1,750 Hours in ASTM B117

Exposed to Gravelometer
HDG G30
InterCoat® ChemGuard 315L
