## NSS Exposed for 1,920 Hours

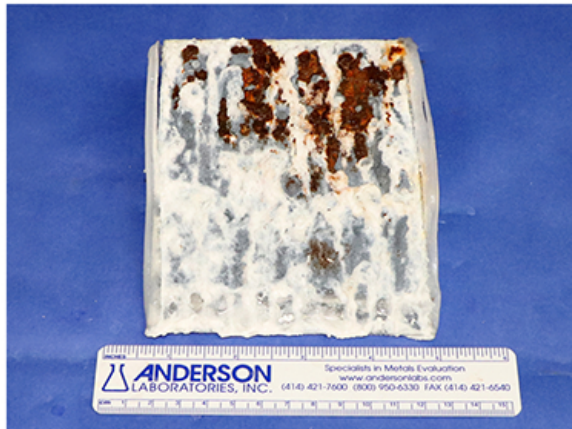
**G235**  
**Overbend (Tool Defects)**

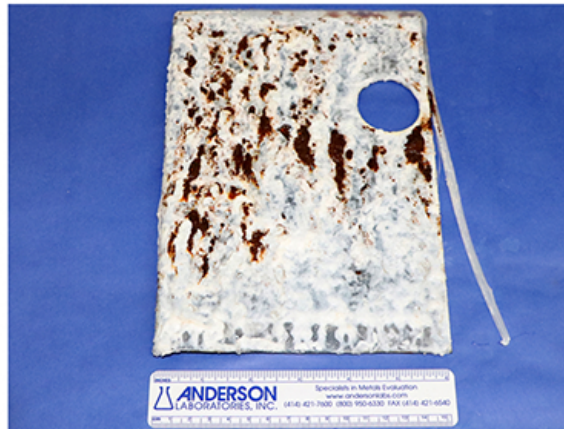
**G235**  
**Flat w/Perf.**

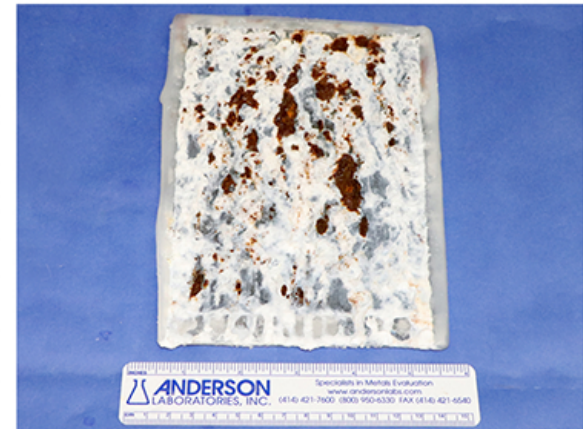
**G235**  
**"Flat" Field**

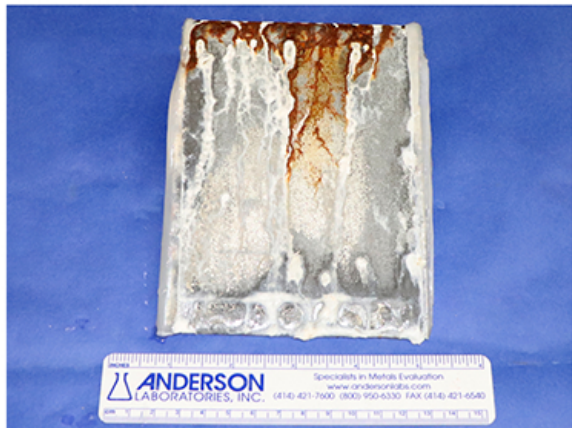
**HDG G40 + CG-AG**  
**Overbend (Tool Defects)**

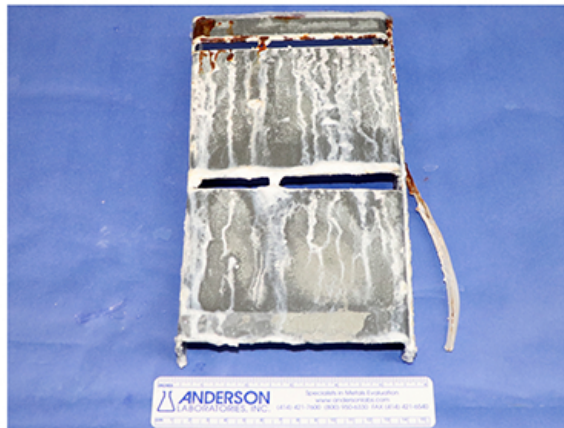
**HDG G40 + CG-AG**  
**Expanded Sidewall - Edge Test**

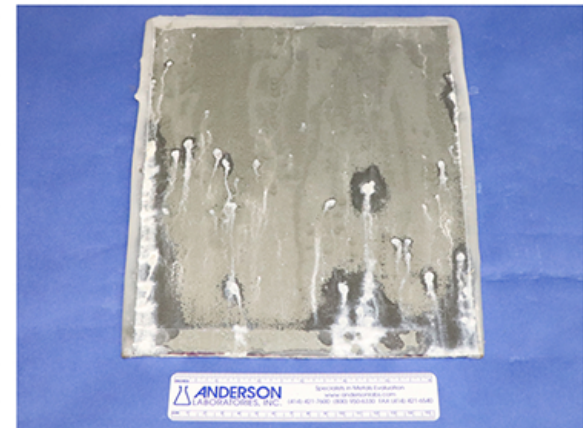
**HDG G40 + CG-AG**  
**"Flat" Field**
